Manhole Inspection Summary

Manhole # S31GG2021MH

Location Address: **5910 MEADOWOOD RD**

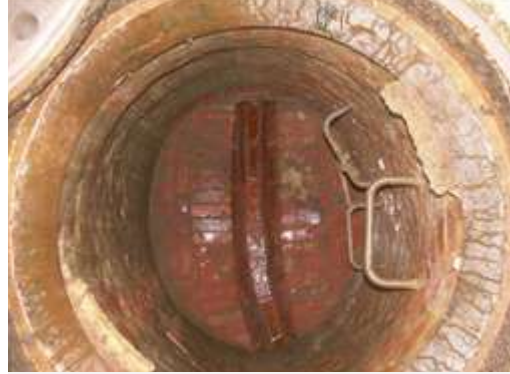
Top View

Bench debris.

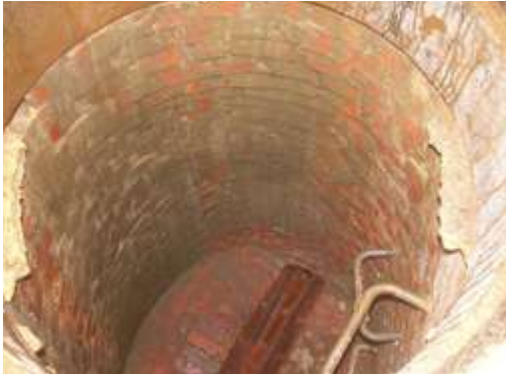
Defect

Adjustment deterioration, loose brick and infiltration. Corbel and Barrel infiltration - other side.

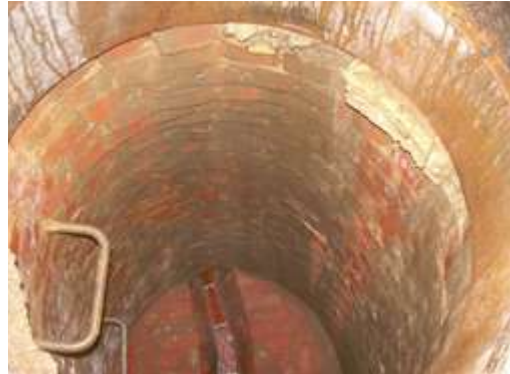
Defect

Adjustment deterioration, loose brick and infiltration. Corbel and Barrel infiltration.

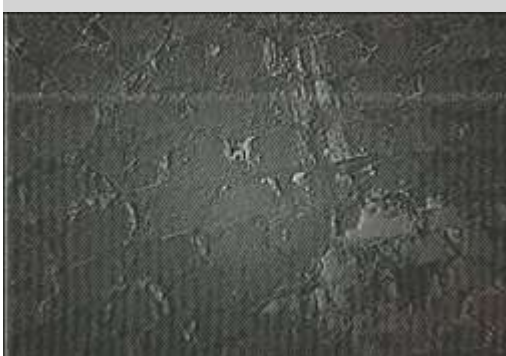
Defect

Barrel deterioration and infiltration.

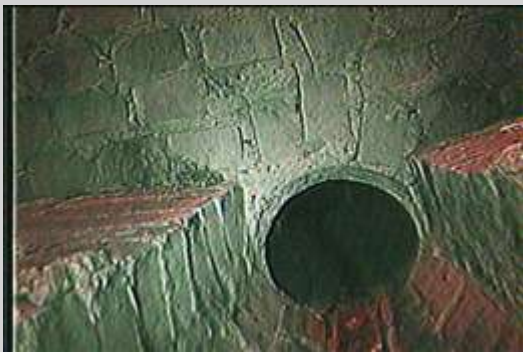
8 in. Circular Gravity Sewer Pipe Out @ 12 O'Clock

Infiltration: **Evidence** Pipe Seal Cond: **Cracked**

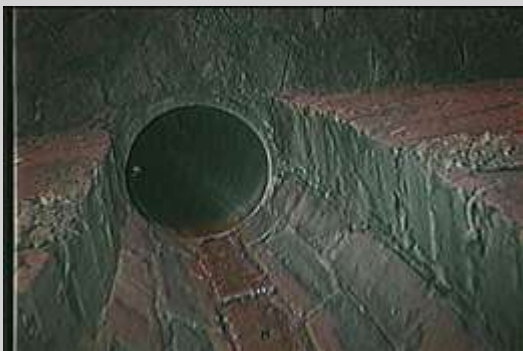
8 in. Circular Gravity Sewer Pipe In @ 5 O'Clock

Barrel deterioration and infiltration. Channel deterioration.
